Electrical incident – exposed live parts when resetting bell control units

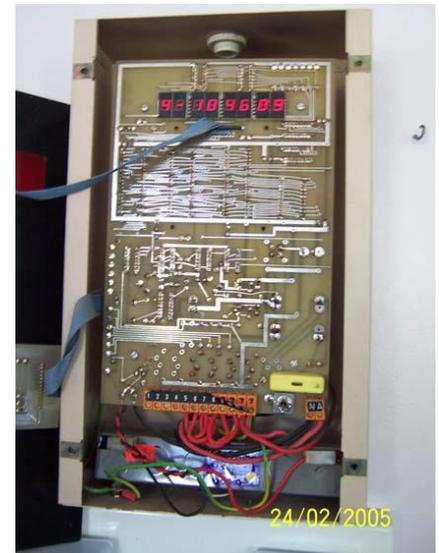
Staff and others are at risk of electric shock when removing the cover of the Simplex 2399 Bell Control Unit. Live terminals are exposed when the cover of the unit is removed to reset the device. The risk of touching the live terminals and receiving an electric shock is significant.

1. Prohibit removal of covers of bell control units (Simplex or similar).
2. Place signage on the cover to advise that it should not be removed by staff.
3. Inform staff of the risks and reasons for this safety precaution.
4. Engage a technician to assess and repair problems with the bell system.
